WATER TRAILER CERTIFICATION GUIDE “BUFFALO/CAMEL/HIPPO”

FORT RILEY DEPARTMENT OF PUBLIC HEALTH

CPT SPRINKLE 15AUG2019

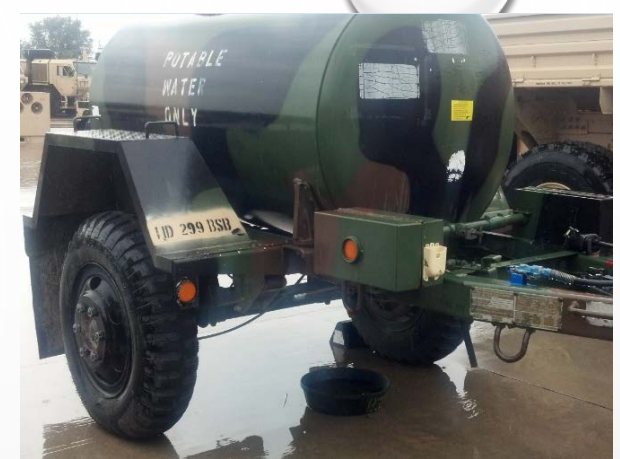
400 GALLON TRAILER (BUFFALO)

- The guiding documents are TB MED 577 (May 2010) and DA 5457 (NOV 2005).
- **TM 9-2330-267-14&P** is the governing technical manual for the M149 series and **TM 9-2330-397-14&P** for the M1112 series “buffalo”.
- Routine PMCS from the TM does not address the sanitary requirements of TB MED 577.
- All water containers should be inspected quarterly by field sanitation teams and sanitized/certified annually by PM.
- (/) is a discrepancy; (X) is a FAILURE

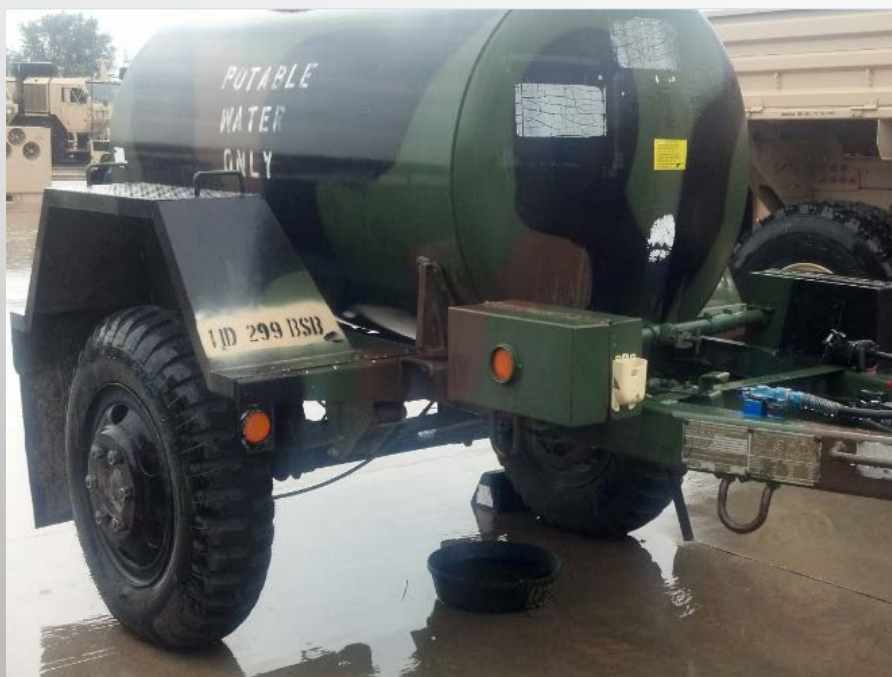
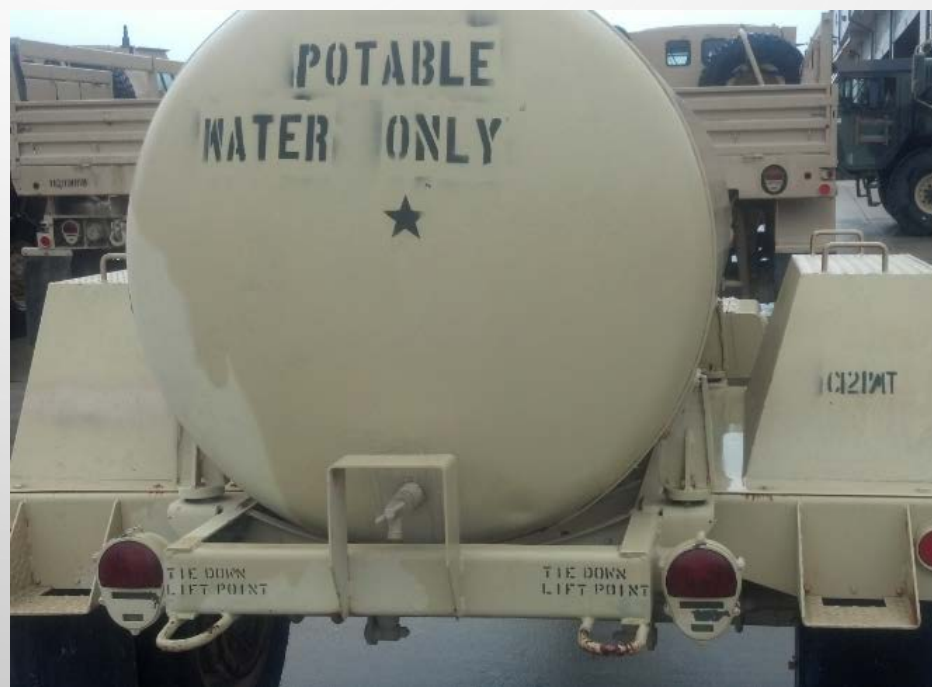
BUFFALO CONTAINER EXTERIOR

- The exterior of the buffalo must be marked on both sides with a legible “POTABLE WATER ONLY”. (/)
- The tank exterior must be clean in good condition – no excessive corrosion, damage, caked on mud, etc. (/)

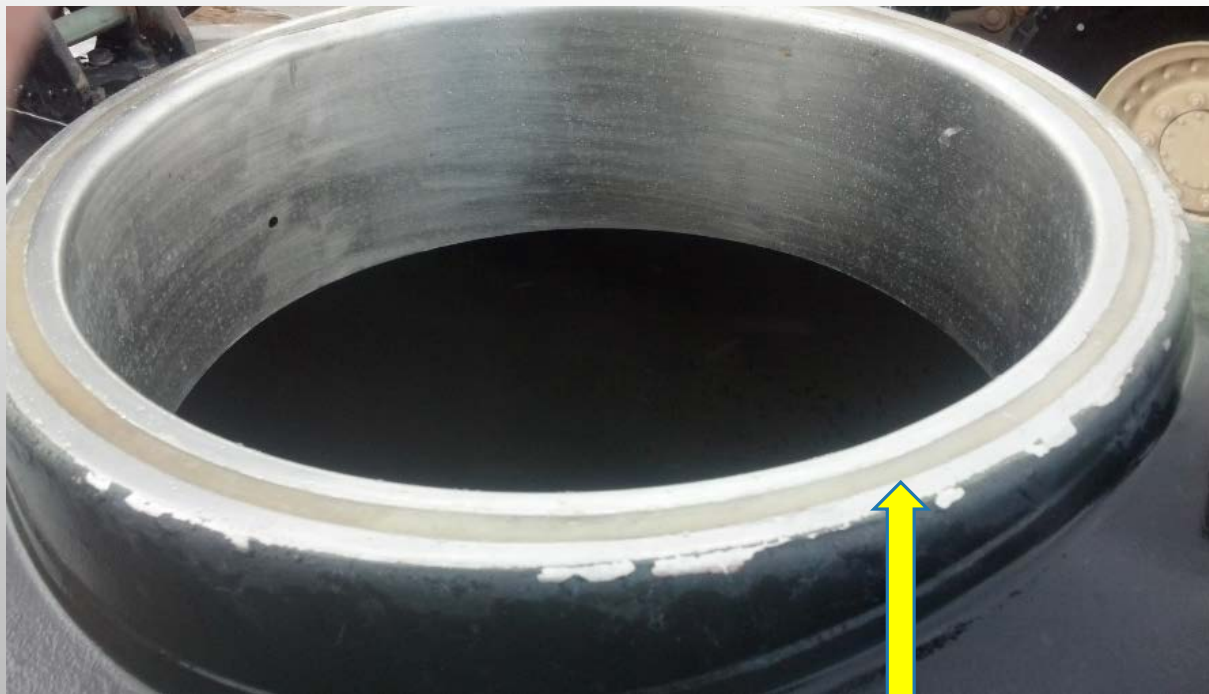
- Rubber gaskets – the seal formed by the manhole cover lid to the container is of prime importance in keeping contaminants from the stored water. Both upper and lower gaskets should be in clean, non-damaged condition in order to maintain a good seal. The lower gasket should be level with both inner and outer container hull, without excess sealant that can flake off into the water. (X)

Gasket level without excess sealant

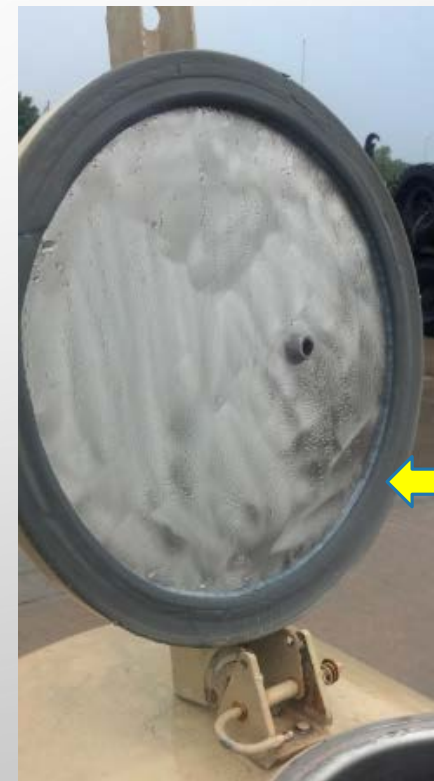
Upper gasket clean and not damaged or dry rotten

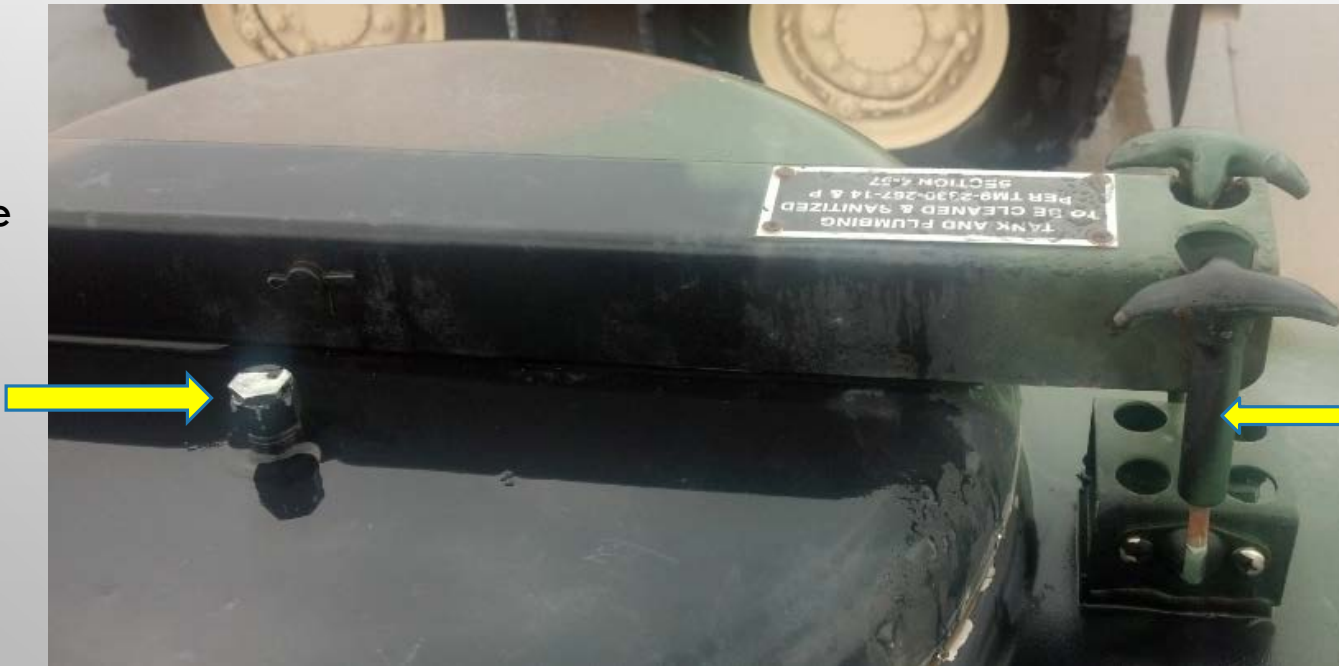
- Locking mechanisms must be operational to ensure a good seal is maintained. (X)
- There should be no rust and the unit's insulation should be intact and not exposed. (/)
- The Pressure Relief Valve must be operational. To test, blow into the inlet on the bottom of the manhole cover. The valve cover (the very top piece of the pressure relief valve) must move easily. (/)

Pressure
relief valve
inlet
w/sealant

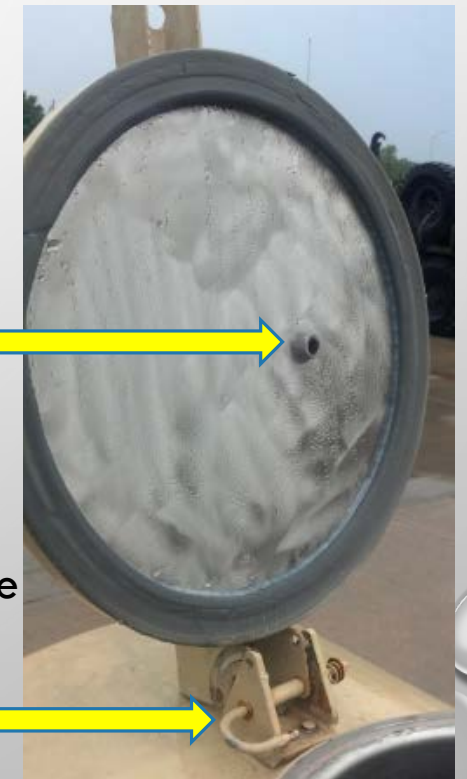
Ensure locking
mechanisms are
functional

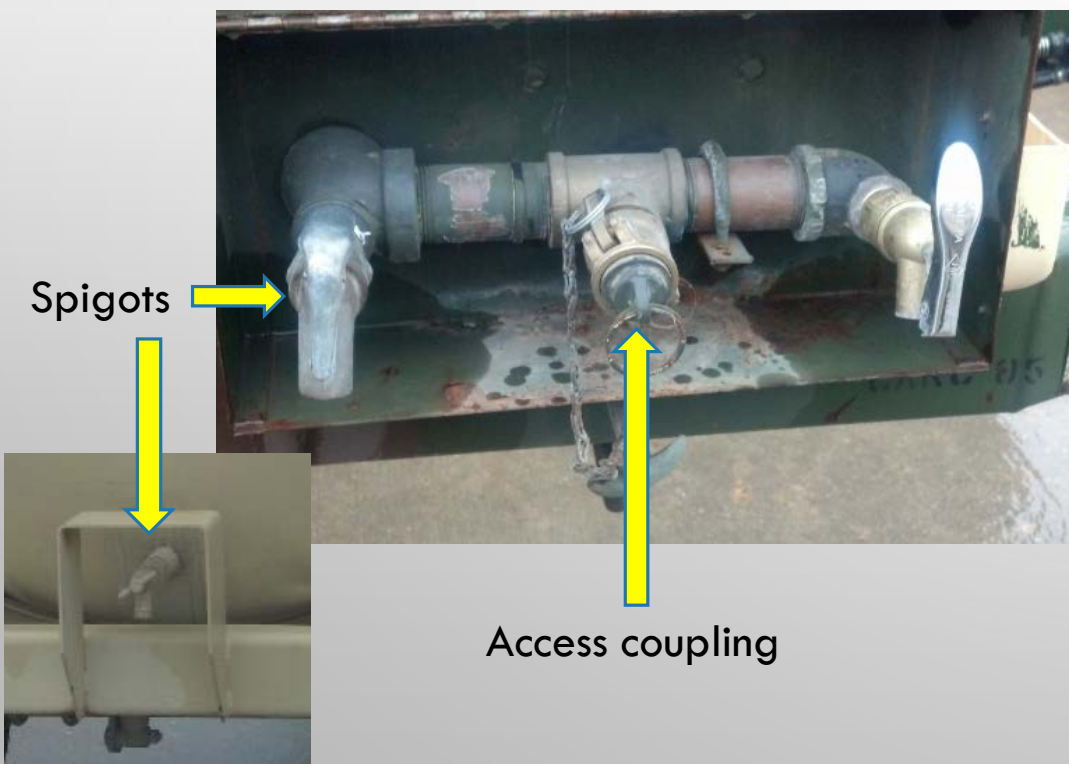
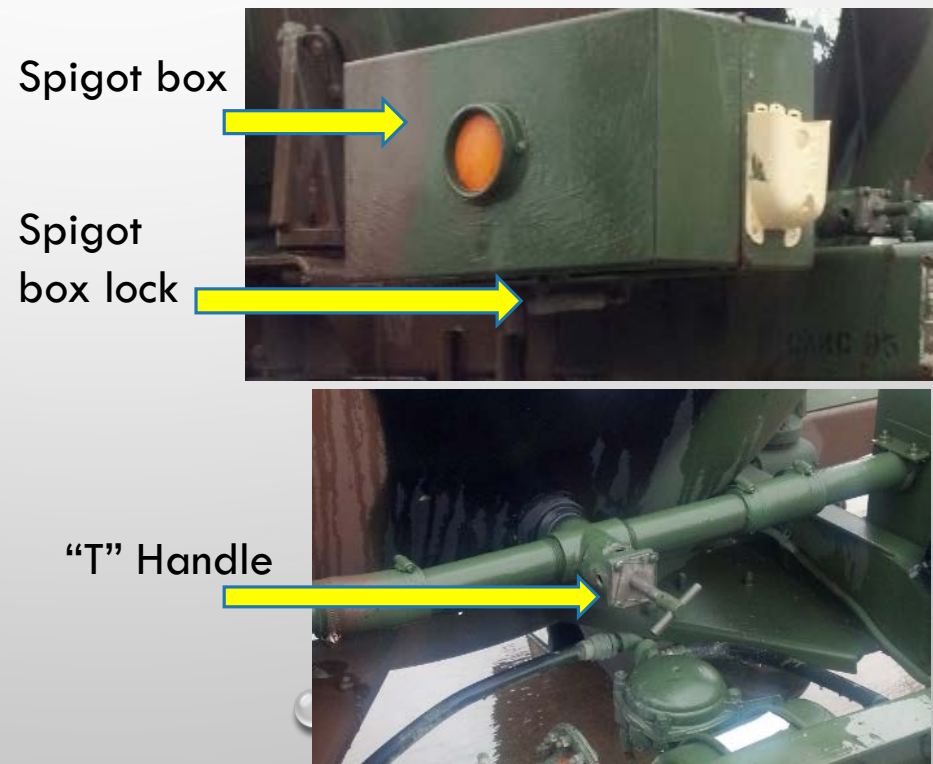
BUFFALO DISPENSING SPIGOTS

- All five spigots (four in the two spigot boxes and one in rear) must be functional. The piping from the tank must be intact. There should be no burst pipes from ice damage or leaks from the spigots or the passenger side access coupling. **Testing must be done with potable water ONLY!**
- The “T” handle controls water flow to the spigots and should operate easily. The valve is open when the handle is pushed toward the tank. (X)
- The spigot boxes must be intact and the locking mechanism on each operational. (/)

Close the “T” handle and drain the spigots after use! This will PREVENT ICE DAMAGE that will deadline the unit!

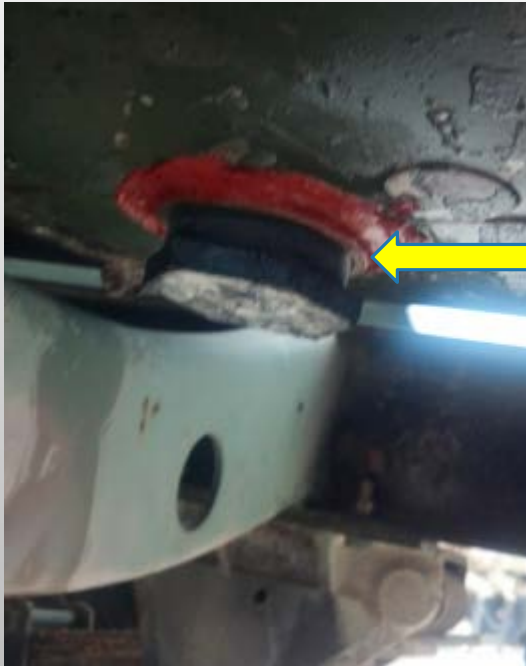
- The lower drain plug must be installed hand tight. **TOOL USE WILL DAMAGE THE THREADS.** (X)
- There must be no crack between the tank hull and the drain that exposes the insulation. (/)
- The plug/hold threads must be undamaged and no corrosion present. (/)
- A class III leak in any of these components will result in a deadline. If necessary, PFTE/plumber's tape can be applied to the **lower** threads of the plug (to limit flaking off into the tank, even though it is inert). (X)

Drain Plug installed
hand tight; gap
between hull and drain
sealed; no leaks

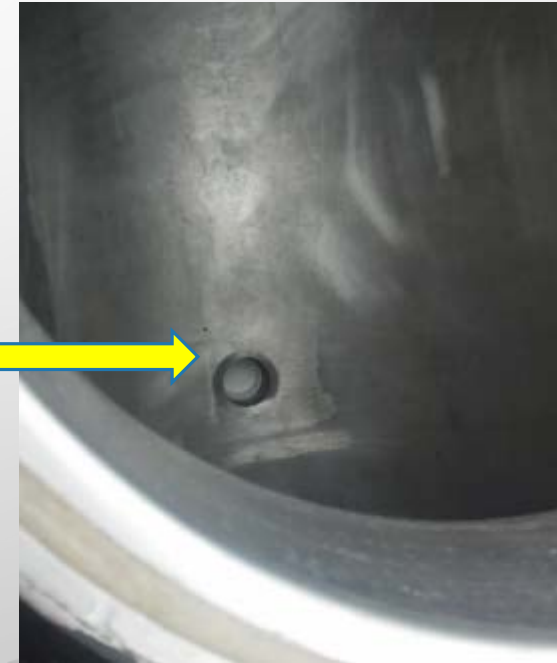
Plug and drain
threads
undamaged
with no
corrosion

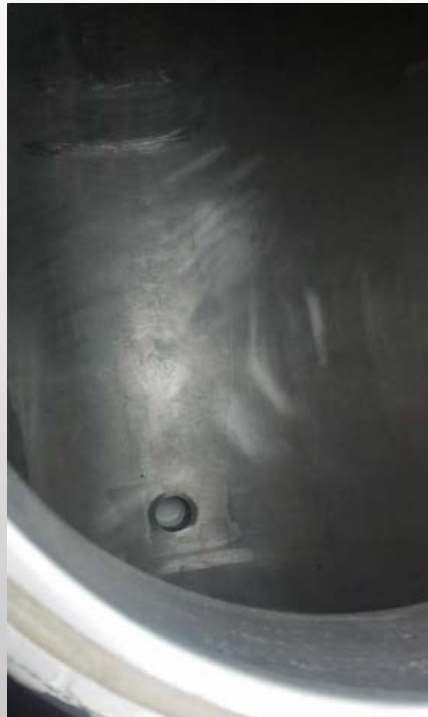
BUFFALO CONTAINER INTERIOR

- The interior tank must be clean and in good repair; with no paint or other coating; or any cracks or dents exposing insulation. (X)
- There should be no/an absolute minimum of rust in the interior of the tank. **Refer to the TM and TB MED 577 for proper cleaning procedures. Power tools will damage the tank, DO NOT use them to clean! (/ or X)**
- This is a confined space. **Ensure you have proper training before entry!**

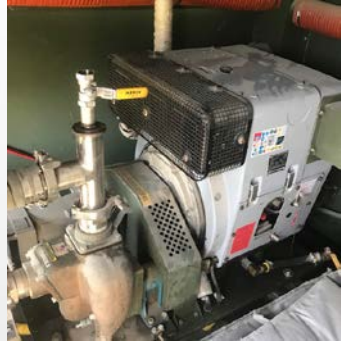
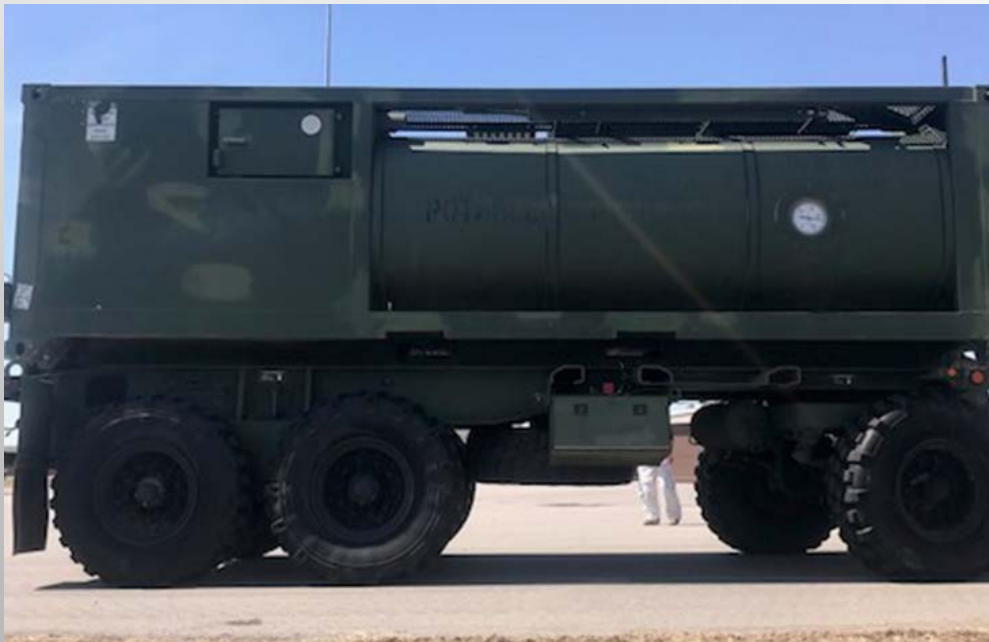
2000 GALLON WATER TANK (HIPPO)

- The 2000 gallon water tank trailer (“Hippo”) is inspected with Section 2 of the DA 5457. The applicable TM is 10-5430-244-10.
- In addition to the items on the form, **ensure the self-contained generator is fully fueled and operational (X).**

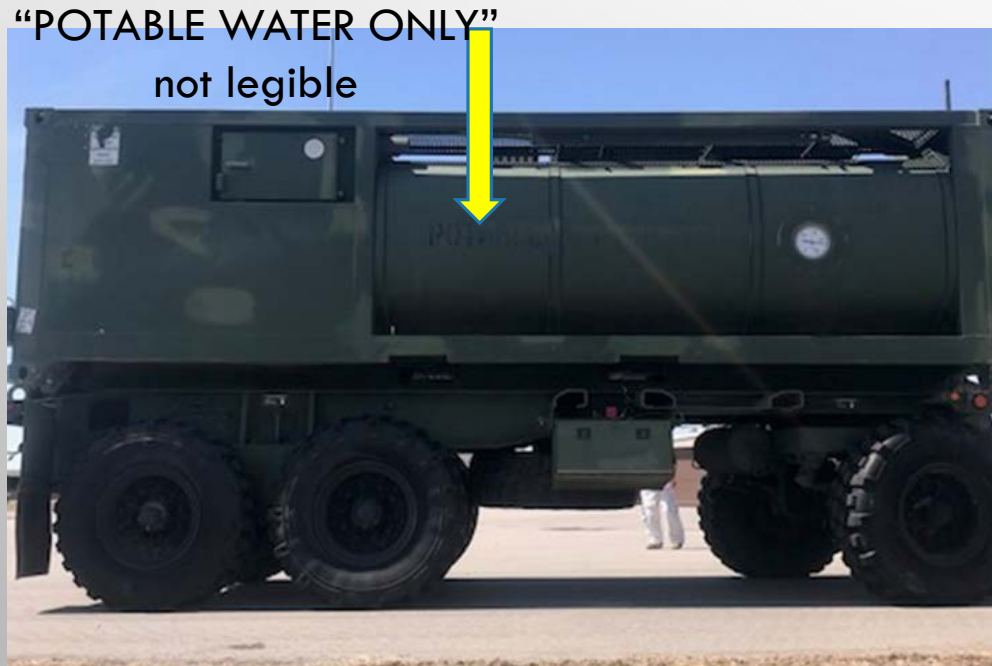
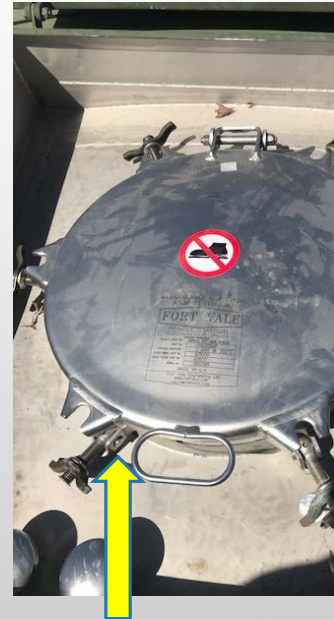
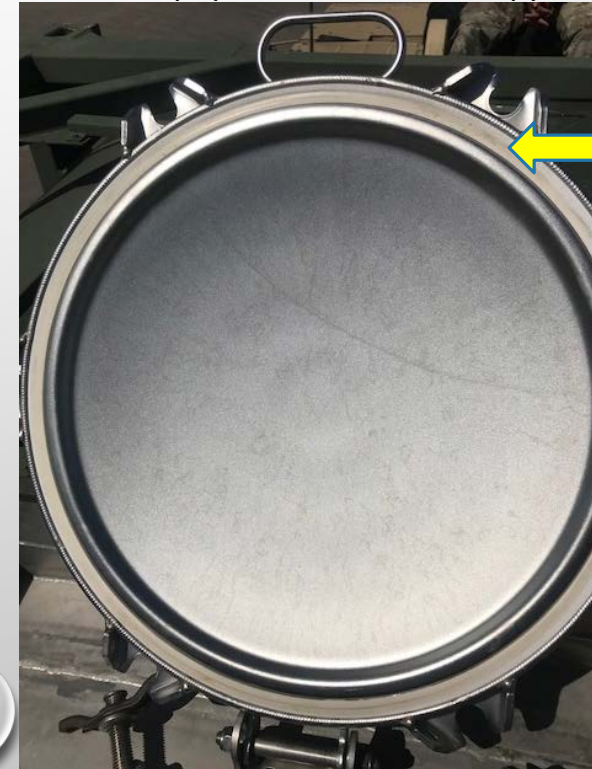
HIPPO CONTAINER EXTERIOR/MANHOLE

- The exterior of the hippo must be marked on both sides with a legible “POTABLE WATER ONLY”. (/)
- The tank exterior must be clean in good condition – no excessive corrosion, damage, caked on mud, etc. (/)
- Manhole hatch gasket must be in good repair (X) and hatch locks must work (X) with no rust (/).

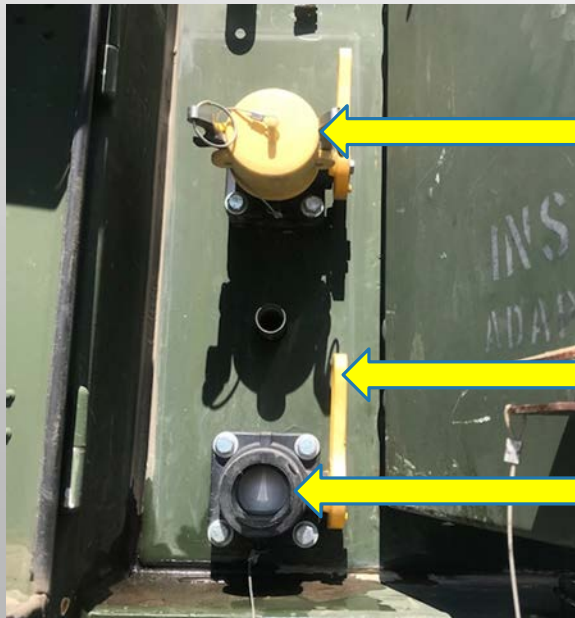
- The Valve lever must operate easily (/), with the dust cap attached (/) and hose coupling threads undamaged (/)
- The tank interior must be clean in good condition – no rust or paint, etc. (/ or X)
- This is a **confined space**. **Ensure you have proper training before entry!**

Dust Cap attached

Valve lever operates easily

Hose coupling threads undamaged

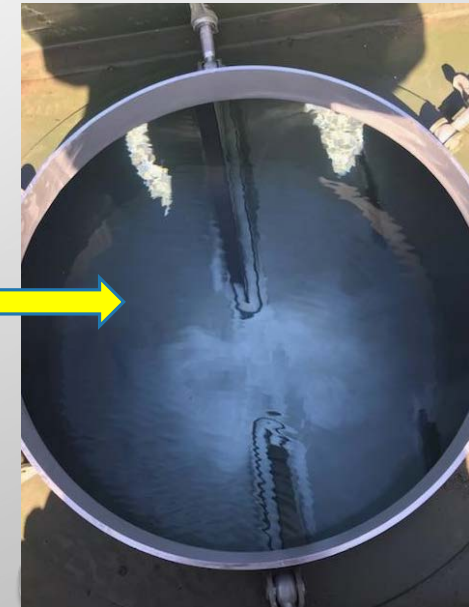
Clean with no
rust or paint

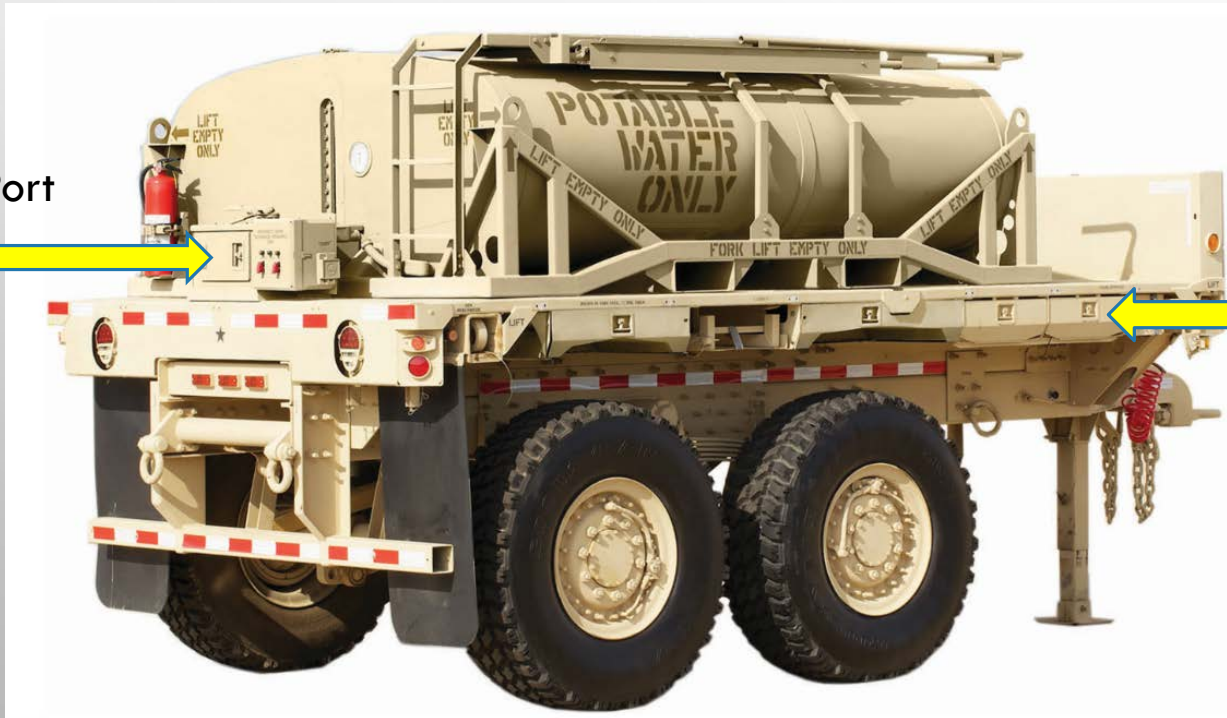
- The replacement for the 400 gallon “buffalo”, the 800 gallon water tank trailer “Camel” is a hybrid of the buffalo and hippo. It is effectively is a smaller hippo with a gravity-powered port instead of a pump. (A pump/heater is optional). It is equipped with both a spigot and a distribution station.
- The Camel is inspected with (mostly) Section 2 of the DA 5457, just like the hippo, as well as parts of Section 1 (for the access port and valve).
- The applicable TM is **10-2330-402-13&P**.

Access Port
Box

Spigot /
Distribution
Station
Storage

Port Valve

Access Port
